<p><b>7.1.6</b> <b>Q<sub>n</sub>M</b></p>	<p><b>Quality audits on environment and energy are regularly undertaken by the institution</b> 7.1.6.1. The institutional environment and energy initiatives are confirmed through the following</p> <ol style="list-style-type: none"> <li>1. Green audit <span style="float: right;">■</span></li> <li>2. Energy audit <span style="float: right;">■</span></li> <li>3. Environmental audit <span style="float: right;">■</span></li> <li>4. Clean and green campus recognitions/awards <span style="float: right;">■</span></li> <li>5. Beyond the campus environmental promotional activities <span style="float: right;">■</span></li> </ol> <p><b>Options:</b></p> <p>A. Any 4 or all of the above B. Any 3 of the above C. Any 2 of the above D. Any 1 of the above E. None of the above</p> <p style="text-align: center;">} <b>(Opt any one)</b></p> <p>Upload:</p> <ul style="list-style-type: none"> <li>• Reports on environment and energy audits submitted by the auditing agency</li> <li>• Certification by the auditing agency</li> <li>• Certificates of any awards received</li> <li>• Any other relevant information</li> </ul>	<p><b>5</b></p>

# Energy Audit Of TERI SAS Campus

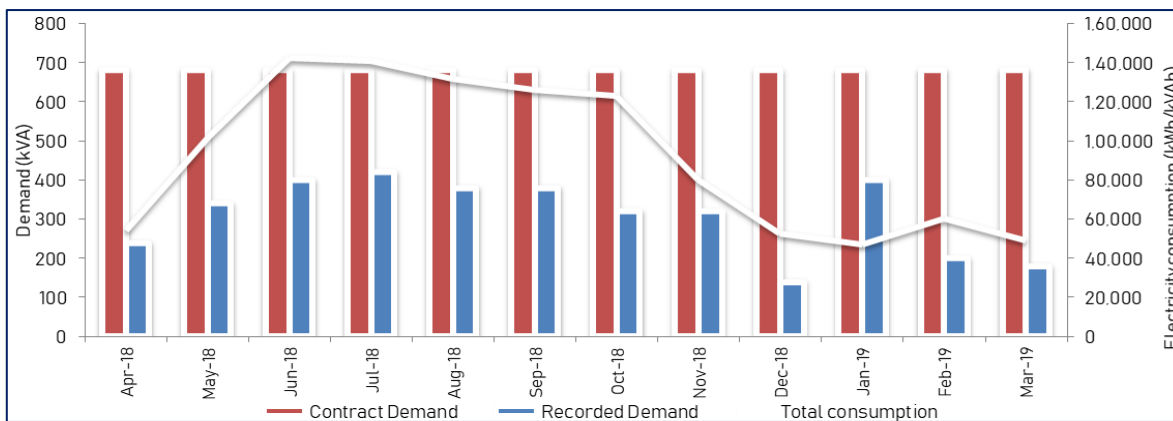
**Figure 3.1a: Contract demand, recorded demand, and energy consumption profile**

As observed from the above figure, the campus has registered a maximum recorded demand of 420 kVA in the month of July 2018 and a minimum recorded demand of 140 kVA in the month of Dec 2018. The weighted average recorded demand for the year 2018 is 310 kVA against the minimum billing demand 140 kVA. The average electricity consumption of the campus from BRPL is 92,413 kVAh per month. Apart from grid power, the facility is having solar rooftop and back-up power generators to cater to the power requirement during the power cut from the grid. The total installed capacity of solar rooftop and back-up power generation system is 48kWp and 880 kVA respectively. The electricity generation pattern of the back-up power system and solar PV and the percentage sharing in total electricity consumption of the electricity is given in figure 3.1b

It has been observed (figure 3.1) that the maximum and average recorded demand of the facility during the FY 2018-19 is 420 kVA and 310 KVA respectively. The facility is paying the additional demand charges for 370 kVA (average) every month.

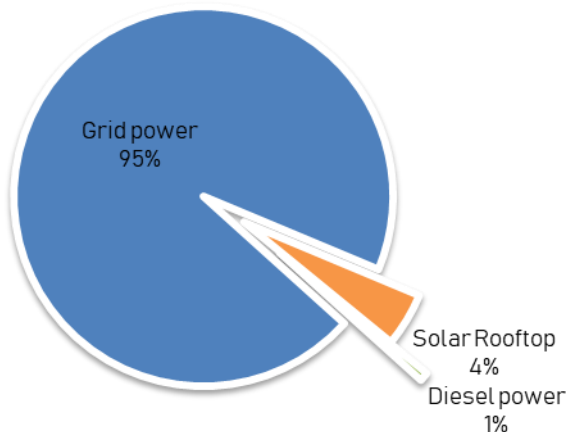
**Figure 3.1b: Share of grid power, backup power and solar rooftop PV system**

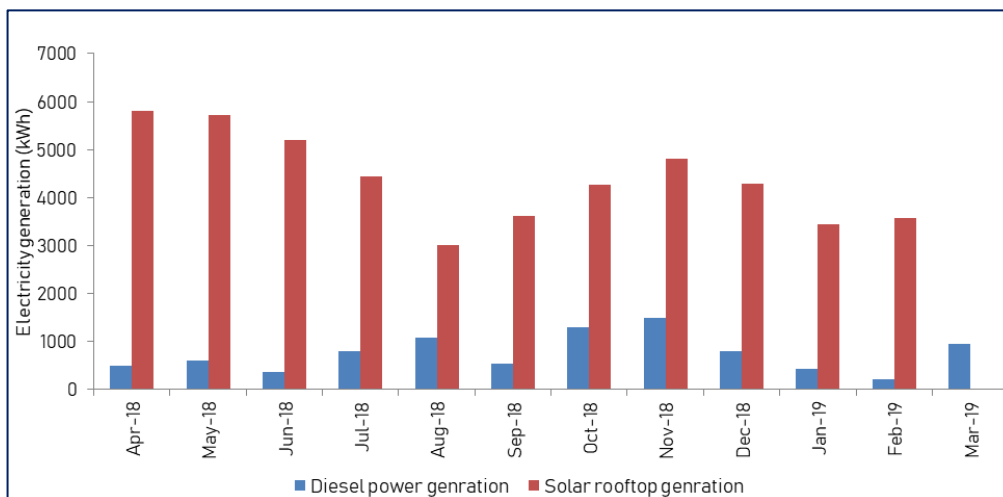
The average monthly electricity consumption of the facility is estimated to 97666 kWh per month in which 95% is grid power 4% is solar rooftop power and 1% is contributed by DG sets. The month-wise energy consumption pattern (solar rooftop and DG) is shown in figure 3.2

**Figure 3.2: Average energy generation of solar rooftop and DG**

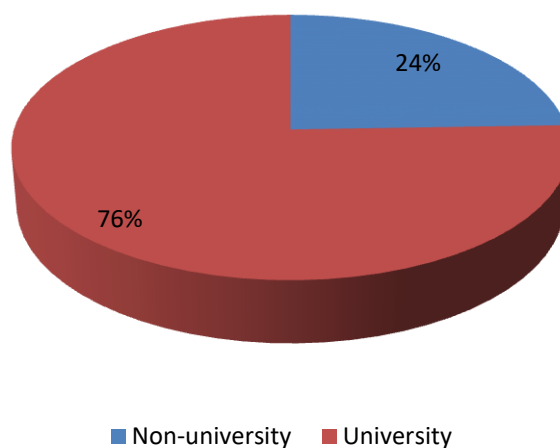
Figure 3.4 shows that the Electrical energy share of the university is around 76% and the Non-university Consumption is around 24%.

**Figure 3.3: Presents electrical energy share of the campus**

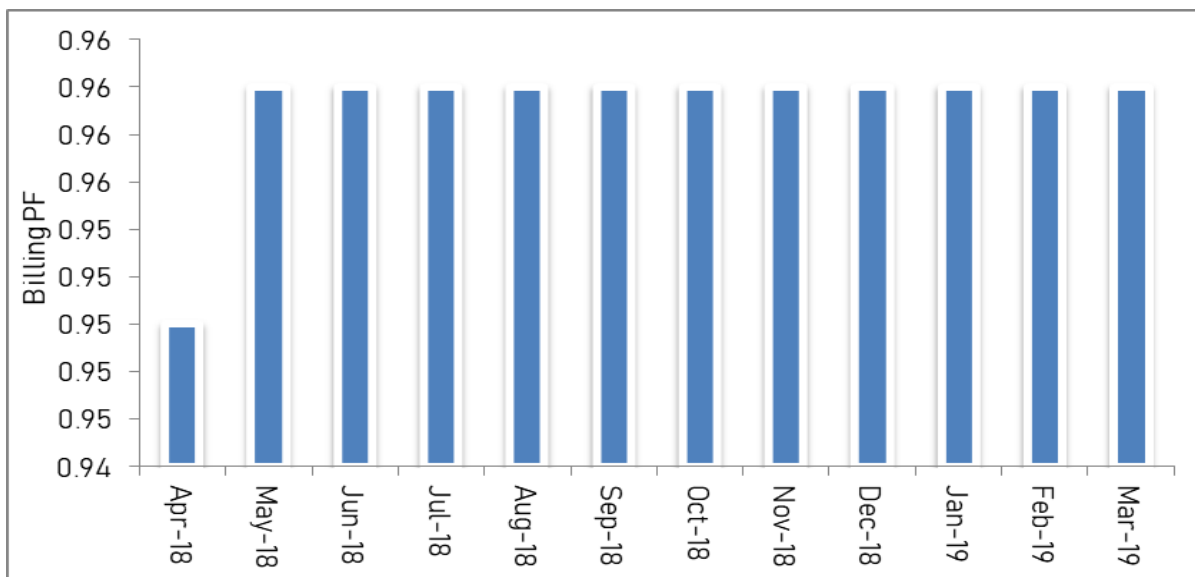
Figure 2.1 Power factor profile of the facility (FY 2018-19)

Since the energy billing in kVAh, the energy charges is inversely proportional to the power factor. The maximum billable demand also depends on the power factor.

It is recommended to improve the power factor to unity (0.999) at the main incomer level (HT side) by applying the fixed capacitor banks and automatic power factor controller at the LT side. Figure 5.1 showing the power factor recorded at incomer of BSES Rajdhani supply during the FY 2018-19. Presently facility has provided power factor correction at the main incomer which can be modified to achieve the power factor till unity.

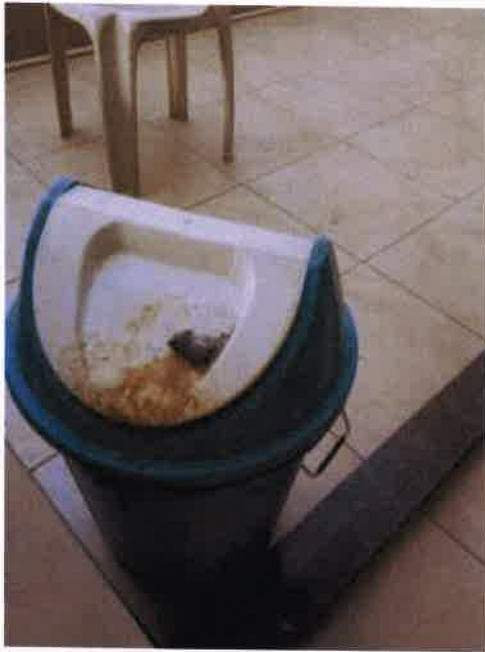
- (b) Faulty selection of bins: The existing bins that has a swinging lid is not suitable for disposal of wet waste (garbage), it often gets soiled. People tend to throw the garbage over the lid (with the assumption that it will slide into the bin). This creates unhygienic condition (see figure 1).

Figure 1. Existing bins for garbage

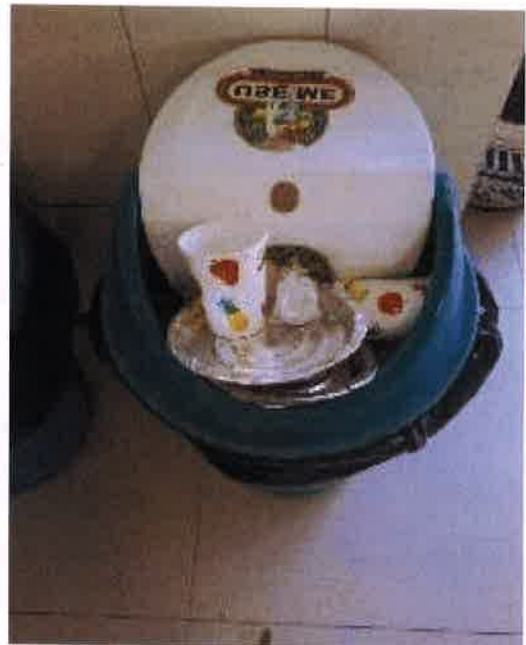
Figure 2. Overflowing bin

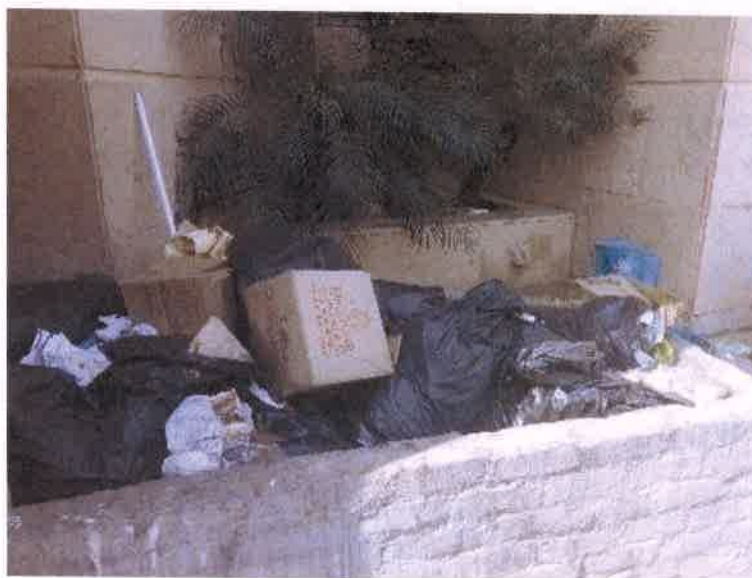
**Figure 3. Waste storage in the university.**

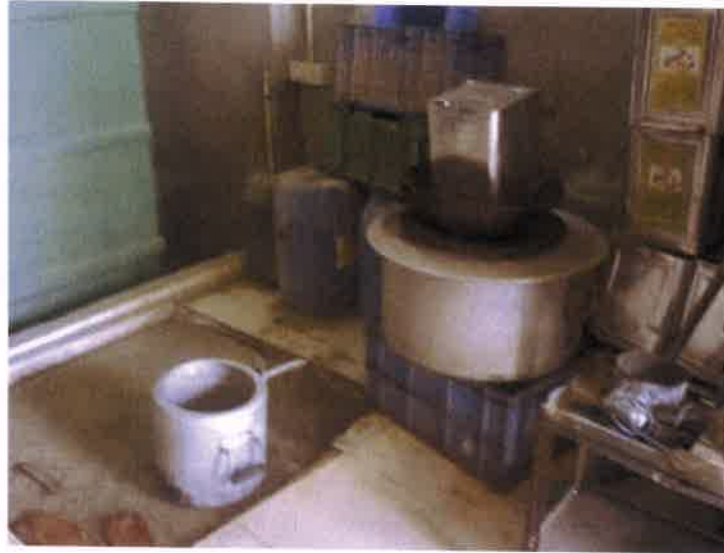
8. No firefighting system is available in the kitchen.

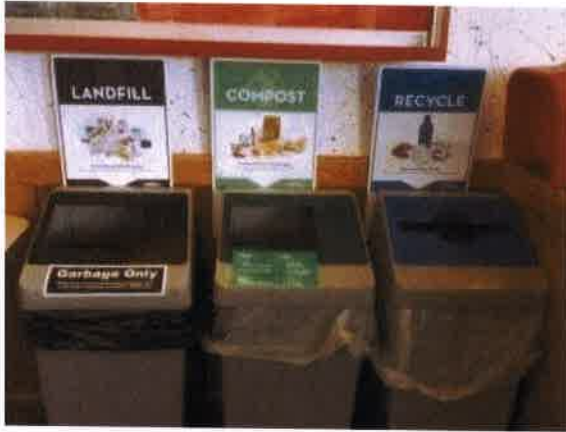
## 5. Cafeteria (Ground and first floor): Figure A4

Figure A4: Suggested design of bin with clear marking and each bin to have a capacity of 5.28 gallons.
